## **ROCK CRUSHER CAMERA MONITORING SYSTEM**

Routt County, Colorado

Road & Bridge Dept.

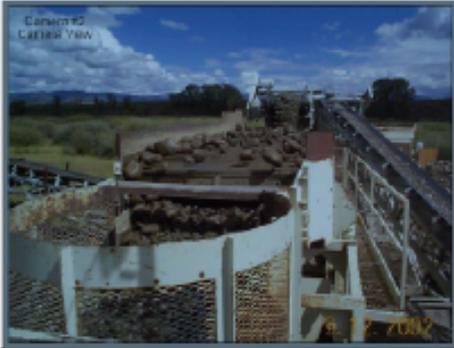
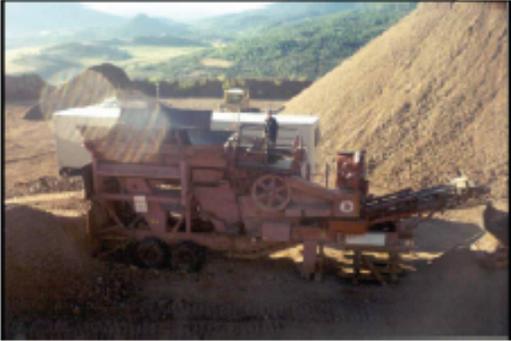
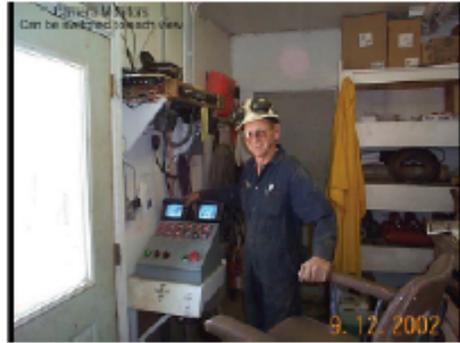
The setup was installed and field-tested by two highly skilled mechanics in less than 100 hours. Two cameras were located on the primary crusher. One looking down into the jaws and another viewing the control speed setting were all we needed. A third camera was mounted on a nearby van to help keep an eye on the rest of the operation. One of the two control motors fabricated on this camera is a windshield wiper motor. It lets us scan the gravel pit for incoming inspectors and other VIPs. The camera cables were strung to the monitors mounted inside the van next to the rest of the control panels. The crusher boss can now run two pieces of equipment from inside the climate controlled van. We purchased a total of two monitors, four cameras, and enough camera cable to view any distant equipment in the pit. One monitor can view two cameras. The cameras have audio capabilities so we can tell when parts sound like they might be breaking. Cost: The cost of the cameras, monitors, and cables was about \$2,000.

We had to do something to stay in business. Most of the rock crushers are set up with an operator's booth. The cost of an operator's booth was between \$10,000 and \$90,000. Cameras and monitor's allow you to operate this piece of equipment from a safe location. This option was clearly the most cost effective and safest choice. Labor, Equipment, &
